SUBJECT: Analysis of Complex E, Tyura Tam Missile Test Center, USSR

1. In response to your requirement dated 16 September 1963 a detailed analysis and line drawing were prepared on Launch Complex E, Tyura Tam Missile Test Center, USSR.

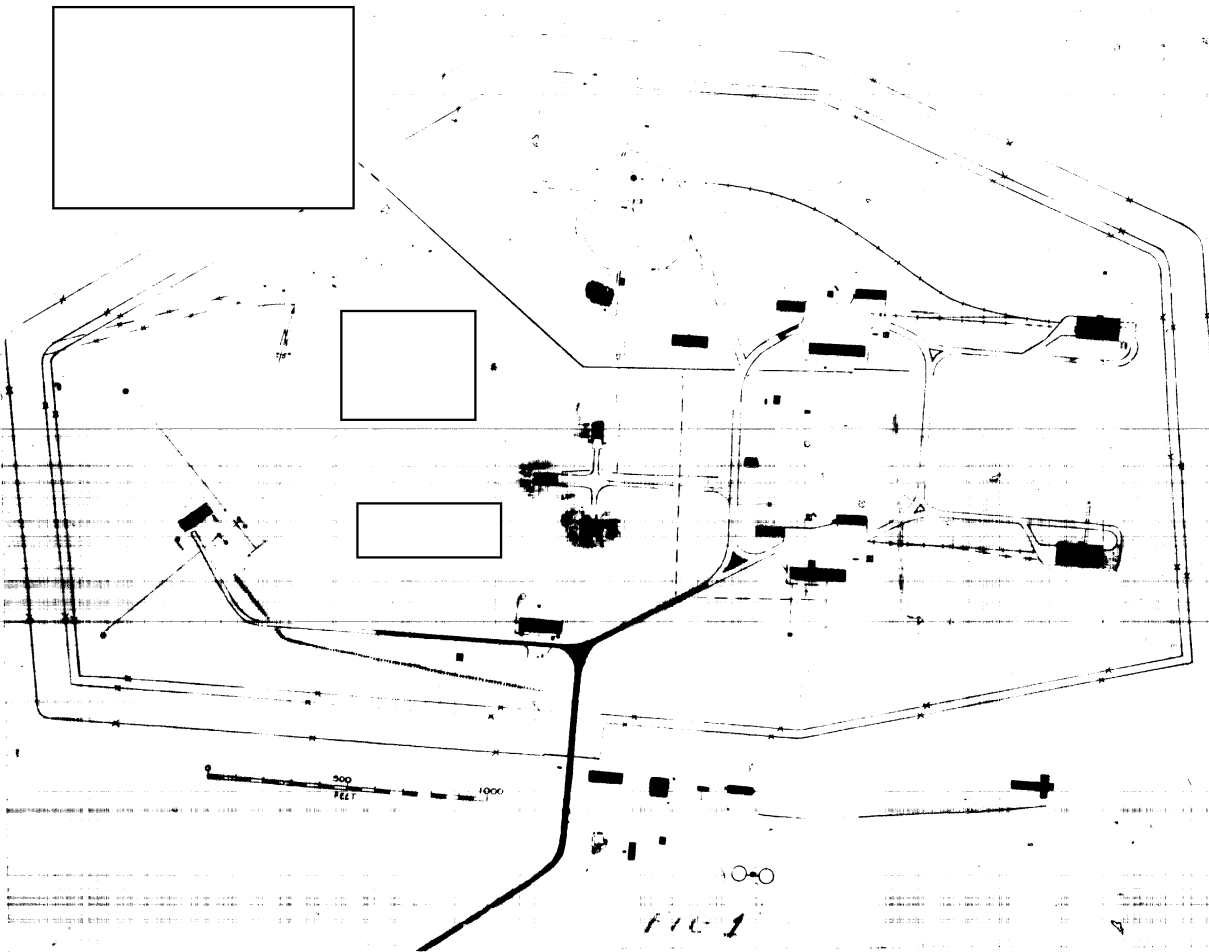
(1) General (Figure 1): This complex is almost completely triple fenced. Two abandoned or dismantled parallel fence lines are located in the northwest portion of the area. These two lines can be identified as early as [redacted]. No fence lines were observed on photography of [redacted]. On [redacted] these two scars passed through what is now the immediate area of Pad E3 and terminated at the present northeast fence corner. However, the two existing parallel fences, which are

separated by a distance of about 40 feet, were also present. No construction activity could be identified in the area of Pad E3 on [redacted] The present 25X1 outermost fence line will probably be extended to enclose the facilities located near the entry road upon completion of those facilities. At present the outer fence is separated from the other fences by a distance of about 140 feet. The roads within the area are blacktop, concrete, and graded earth.

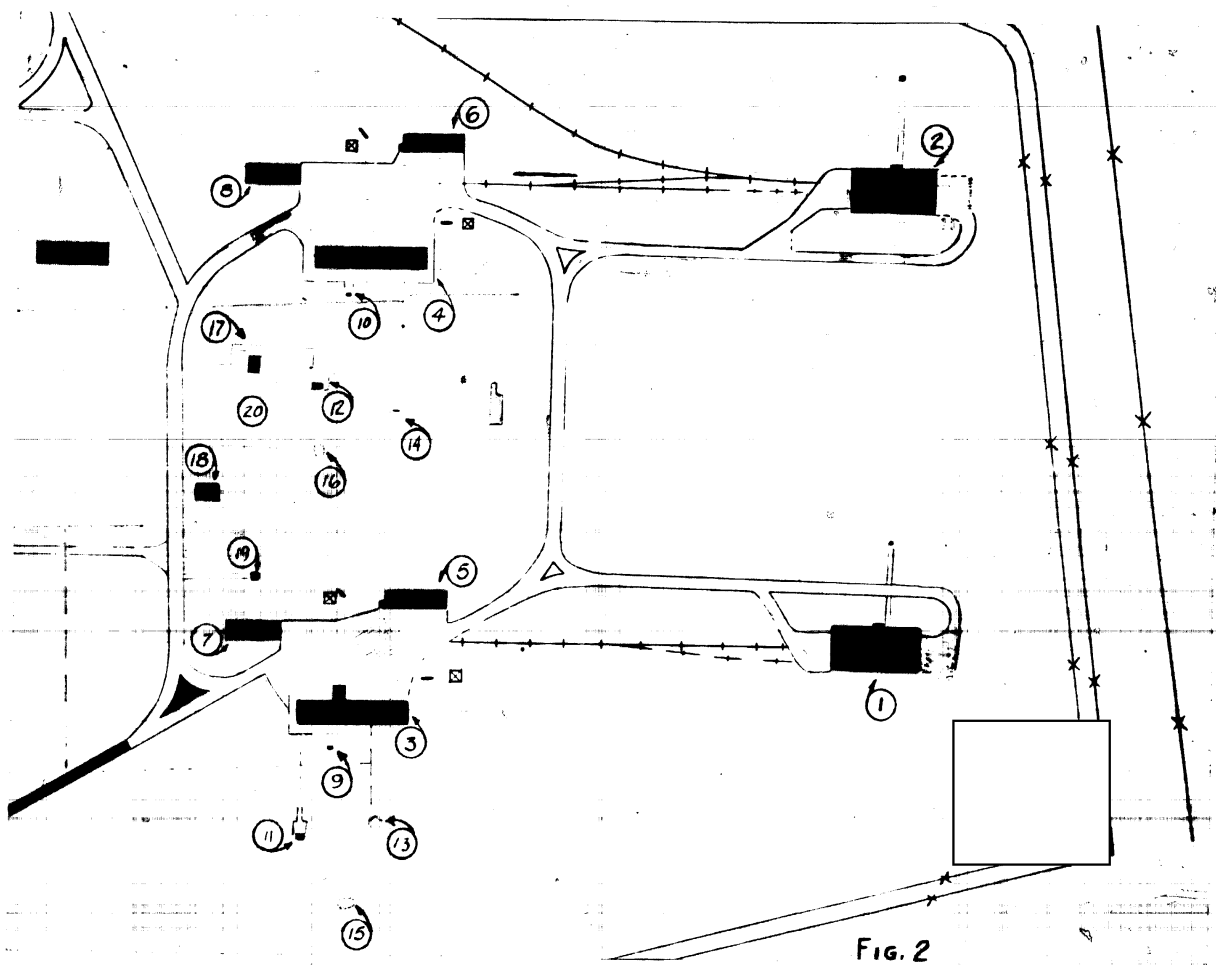
FIG. 2

(2) Pads E1/E2 and Environs (Figures 1 and 2): Most of the facilities at Pad E1 have counterparts at Pad E2. Construction activity, primarily in the form of ditching, is taking place around both pad areas. The missile ready buildings (Figure 2, Items 1 and 2) measure 150 by 75 feet and are about 30 feet high. Each has a very shallow gable roof and an appendage along their north side with a walkway leading to a small unidentified object. Each object is located approximately 145 feet from each building. There are two small vehicles or pieces of equipment about [redacted] feet long parked near the east 25X1 end of Item 1 and a similar small object on the apron at the west end of the same building. There are three 25 foot vehicles parked near the east end of Item 2 and a vehicle or piece of equipment protruding from the front of the building at the west end. Each building has rail (s) connecting the building to the pad. In no case can a rail, per se, be identified either crossing the apron at the west end of the buildings or leading on to the pad. The degree of reliability of extension of the rail trace is reflected in Figure 2 by the use of solid (firm) and dashed (probable) lines. Even in the optimum case (i.e. northernmost trace) can a rail be seen crossing the apron. Therefore it is not unrealistic to assume that all the rail traces actually enter the ready buildings. The road bed south of Item 2 is either heavily stained or in a deteriorated condition as shown by the shading. The launch support buildings (Items 3-8), which are probably concrete, are located on either side of Pads E1 and E2. They measure 195 by 55, 110 by 35, and 105 by 45 feet respectively. One building (Item 3) has an appendage on the north side which measures about 20 feet square. The top of the appendage is lower than the roof of the main section. This appendage could be 25X1 identified as early as [redacted]. Two of these buildings (Items 5 and 6) have a small appendage at their west end which resembles a personnel entrance. The distance between Items 3 and 5, and 4 and 6 is 155 feet. The distance from Item 7 and 8 to the east edge of the pads is about 300 feet.

The pad at E1 is void of activity but has a roughly circular area of stain or discoloration indicating previous activity. This darkened area is centered between the towers adjacent to the pads. The lattice towers at E1 and E2 are separated by a distance of about 255 and 240 feet respectively and are approximately 150 feet tall. Each tower has an inclined structure near its base. The

There are four objects (Items 9, 11, 13, and 15) located in the open area south of Pad E1. These four objects have counterparts (Items 10, 12, 14, and 16) located in the open area south of Pad E2. The function of these eight items is unknown. It should be noted that the pattern of open ditching near E1 is quite similar to the pattern of walkways near E2. The correlation is also enhanced by the fact that the ditching at E1 joins with the ditching west of Pad E2 and then follows a common ditch which terminates outside the fence line. This ditching will be discussed again later in the report.

There are several objects (Items 17-20) located between E1 and E2 which do not have counterparts or are related in function to both E1 and E2. These include two buildings measuring 30 by 15 and 40 by 35 feet (Items 17 and 18), a small building or bunker (Item 19), and a graded area (Item 20) measuring about 125 by 100 feet and containing seven vehicles/equipment. A probable vehicle, 20 feet long is parked west of Item 17.

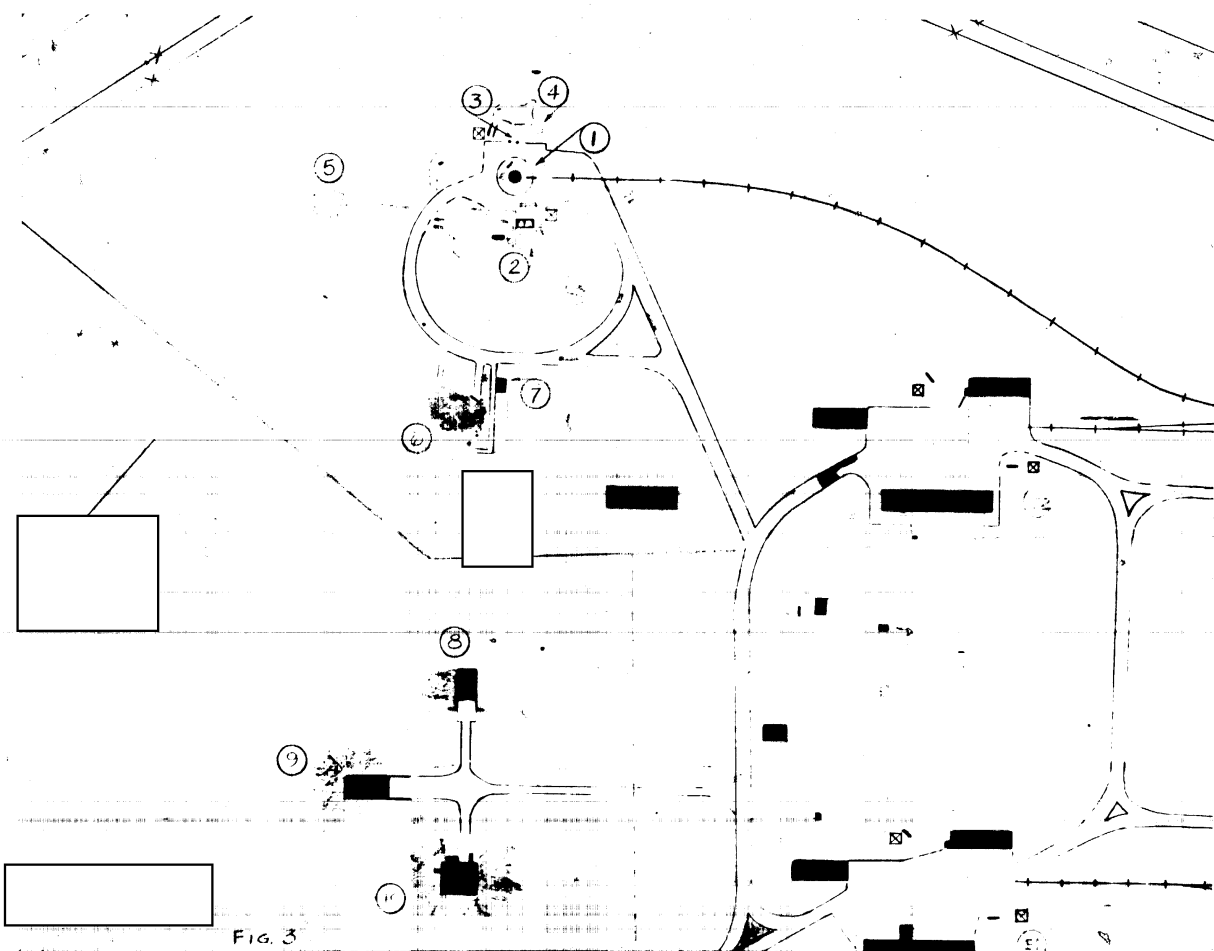
(3) Pad E3 and Environ (Figures 1 and 3): The overall size of the pad measures about 200 by 130 feet. In the center of the pad is a circular image (Figure 3, Item 1) 60 feet in diameter. This image is flush with the pad. In the center of this circle is a circular probable launch stand measuring 15 feet in diameter, and about feet tall. The exact configuration, i.e. cylindrical, truncated cone, etc., cannot be determined due to dark imagery. The rail leads directly to the probable launch stand. It is also located midway between the two 150-foot towers which are about 175 feet apart. These towers do not have the associated structures near their base as do the other four towers. There are two vehicles measuring 25 feet long inside the 60 foot circle and a probable tank truck just south of it. A possible vehicle is positioned in line with the rail. The most prominent structure in the area (Figure 3, Item 2) abutts the south side of the pad. It appears as a structure mounded at the base or constructed atop a

mound. The visible portion of this structure has a "step" configuration. The taller part is on the east side and is estimated to be 25 to 35 feet high. A depression or excavation was observed in this particular area early in the construction of Pad E3. A similar structure was observed at two pads at Kozelsk ICBM site on [redacted] No additional details are available from that mission due to the smaller scale. [redacted]

[redacted] Two very small unidentified objects (Item 3) are located on the north edge of Pad E3. Just beyond the north side of the pad is a mounded semi-buried structure or tank. The shadow of this mound is prominent on several earlier missions. A mound similar to this one is located in the same relative position at the deployed Type IIc launch sites. A prepared parking area (shown by dashed lines) is located north of the pad and connects to the pad by means of a narrow driveway. A shallow rectangular earthen basin (Item 5) is located west of the pad. A mounded probable pipe leads toward the pad. A probable extension of the same mound parallels the south edge of the pad and disappears in the shadow of the mound. The basin is so located that liquids could gravitate to it. A large mounded structure (Item 6) and a building (Item 7) are located south of the loop road serving Pad E3. The building measures 30 by 15 feet and abutts a narrow driveway which terminates near a small object south of Item 6. There is evidence of a ground scar leading from this building toward the triad. The mound has a possible vehicular entrance which is served by a driveway. Another drive or walkway is located further to the west but no entrance into the bunker can be identified.

(4) Triad Configuration (Figures 1 and 3): The triad configuration is served by a well graded improved road. The road surface or aprons immediately in front of the three structures is concrete. Construction activity in the form of ditching is taking place in the area. Debris from the ditch which parallels the entry road has been dumped onto the road with little regard for traffic. This road was also interdicted by a trench which has been back-filled. The three structures are flat roofed (Figure 3, Item 8-10) and measure 60 by 40 feet, 80 by 45 feet, and 65 feet square respectively. All three structures are concrete and partially earth mounded on the sides as shown in Figure 3. Each has retaining walls constructed at the entrance. The roof of the structure to the north (Item 8) is very dark when compared to the other two structures. A narrow object or vehicle, at least 30 feet long, is parked in the shadow of one retaining wall at Item 9. The plan view of the south structure (Item 10) is more complex than the other two. It has a small object protruding from a point near the base along the west side. This protrusion may be earth covered at a later date. This structure also has an appendage or overhang along its north side. The retaining walls may be under construction at this structure.

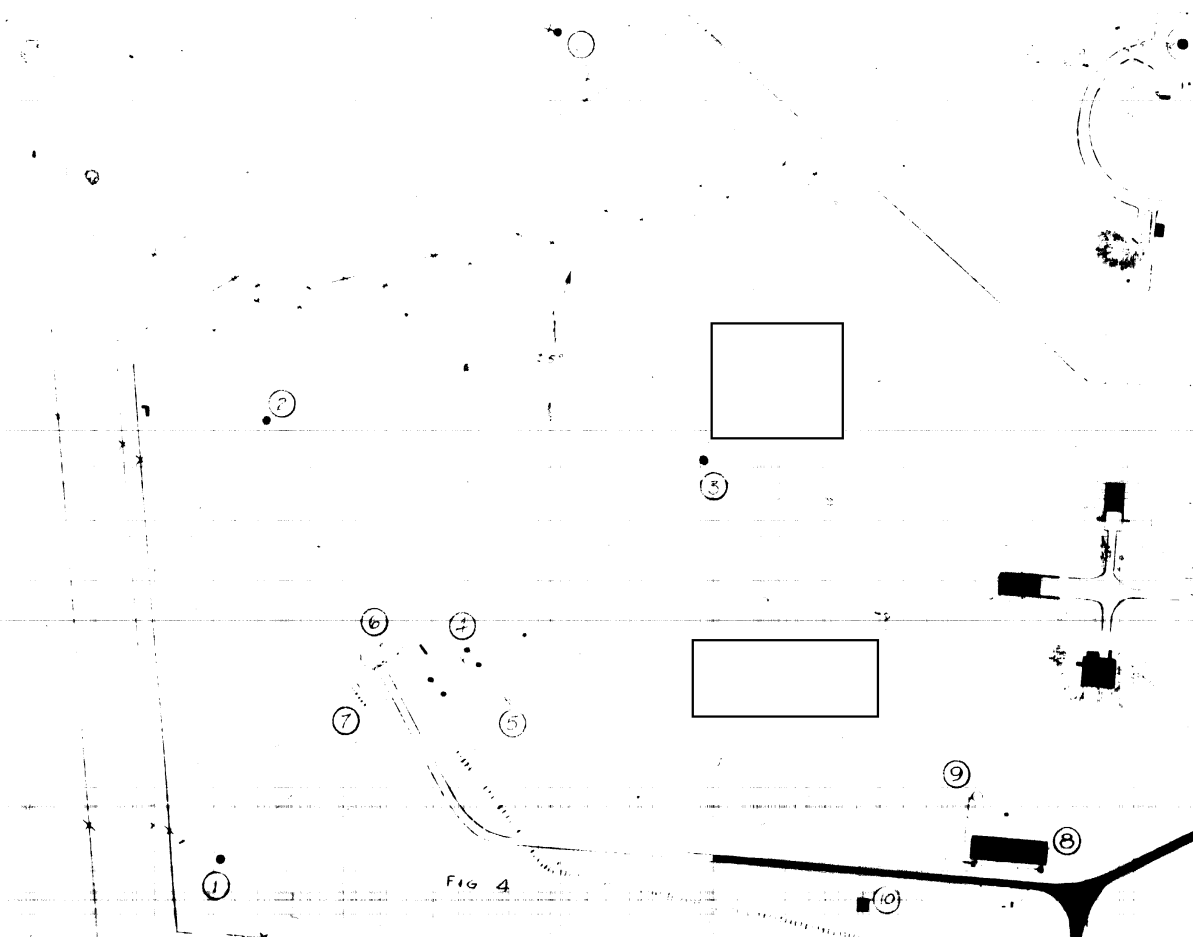
(5) Electronics Facility (Figures 1 and 4): The electronics facility contains three probable domed antennas (Figure 4, Items 1-3) forming an isosceles triangle, four probable terminal structures, (Item 4) and two possible antennas (Item 5). The distances from Item 1 to 2 and 2 to 3 is 860 feet. The distance from Item 1 to 3 is 1,215 feet. A fourth possible domed antenna (Item 6) is located near the north fence line and is 860 feet from Item 3. A ground scar can be identified leading from Item 3 toward Item 6. There are four small objects (Item 4) which may possibly be terminal or junction facilities. A short leg of the antenna (Item 5) extends southeast and branches to terminate at two unidentified objects, possibly antennas. A parking hardstand and a small building (Item 6) and five very small unidentified objects (Item 7) are located near the terminus of the road serving the facility. A 135 by 45 foot building (Item 8) is located just north of the road serving the electronics facility. To the rear of the building is a structure or possible dome (Item 9) measuring 15 feet in diameter. There are three other unidentified objects, one to the rear and two in front of Item 8. Across the road is a parking area containing two small vehicles. West of the parking area is a building (Item 10) which measures 25 by 20 feet.

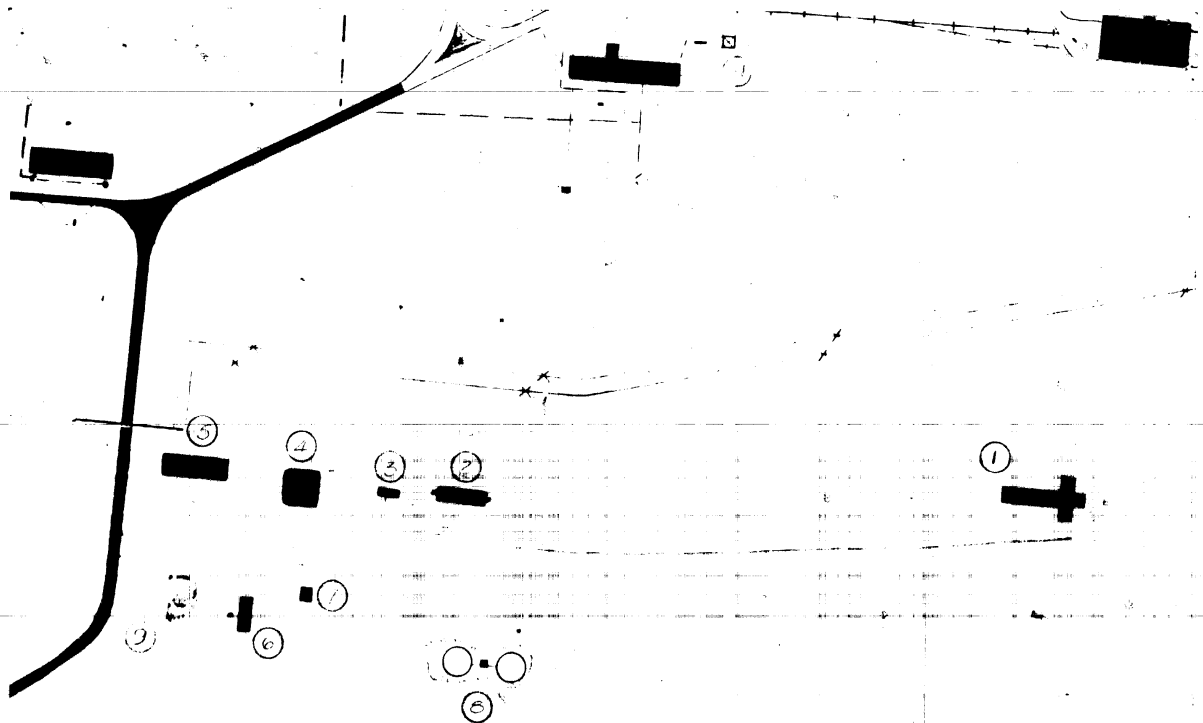
Fig. 5

(6) Ancillary Facilities (Figures 1 and 5): There are six buildings, two subsurface tanks under construction, a steam/power plant, and a possible buried tank or structure located outside the south fence line near the entrance to the launch area. The outermost fence will probably enclose this area after construction is completed. A T-shaped building (Figure 5, Item 1) is located near the terminus of a long open ditch and measures 150 by 90 feet overall. Other buildings include a barracks-type building (Item 2) measuring 95 by 25 feet, a shed 35 by 20 feet (Item 3) and a step-roof building (Item 4) measuring 60 by 65 feet. The higher portion is 40 feet across and the lower

portion 20 feet across. This building is under construction and a crane is located nearby. Also included is a 120 by 40 foot building (Item 5), a steam/heat plant measuring 60 by 25 feet with a large stack (Item 6), and finally a small 25 by 20 foot building (Item 7). There are two subsurface 50-foot diameter tanks (Item 8) under construction. A buried tank or structure (Item 9) is located below and contiguous to the east side of a prepared parking area or hardstand as shown. A mounded pipeline or conduit can be seen paralleling the main access road serving the launch area but disappears near the bend in the road.
